Subject: Department of Natural Resources Washington Geological Survey,
School Seismic Safety Assessment Project, Contract No. AE 410 -
Seismic Evaluation for **Highline School District**

School Buildings Evaluated in the Highline School District

Highline, Woodside Site, Annex

Highline, Woodside Site, Main Building

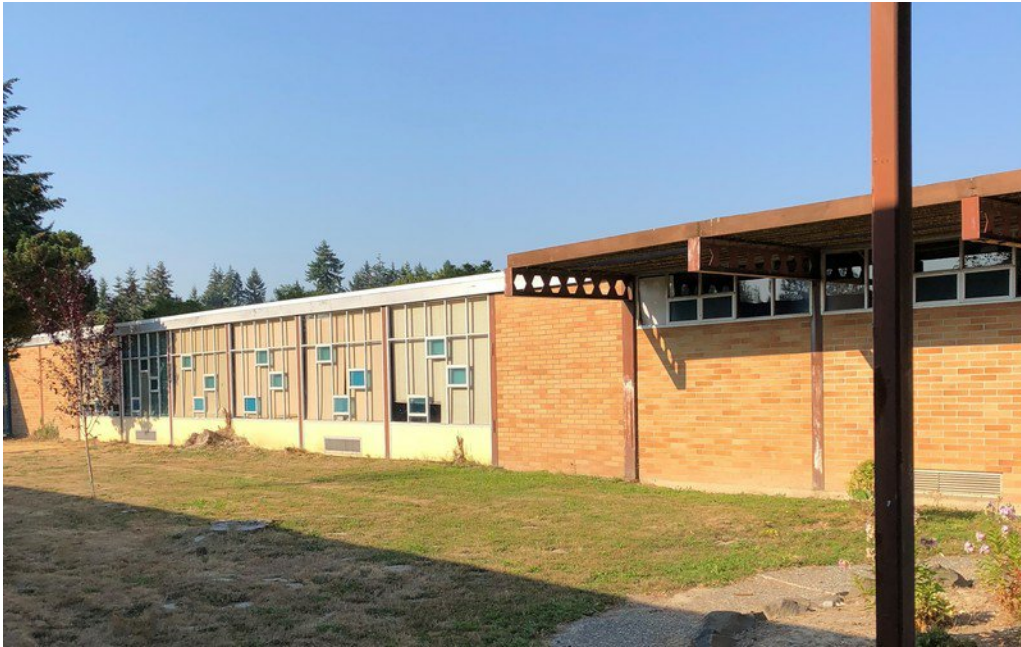
Figure 1-1. East exterior wall of Annex (looking southeast)

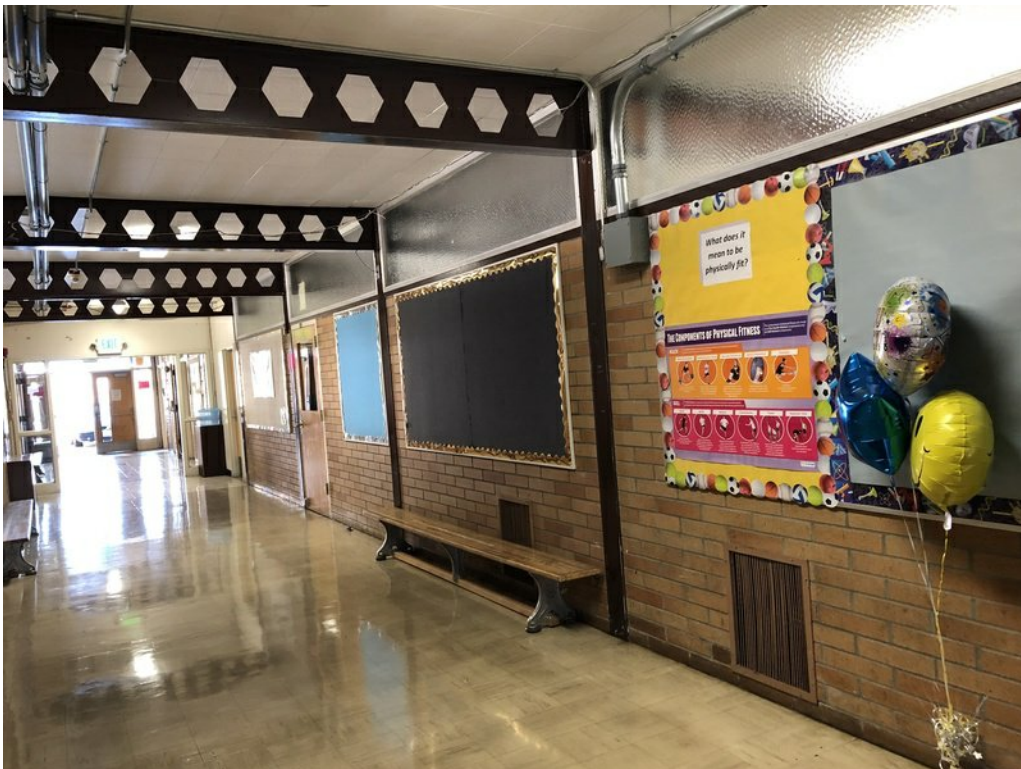
Figure 1-2. Castellated beams in corridor, interior brick corridor walls with upper band of glazing

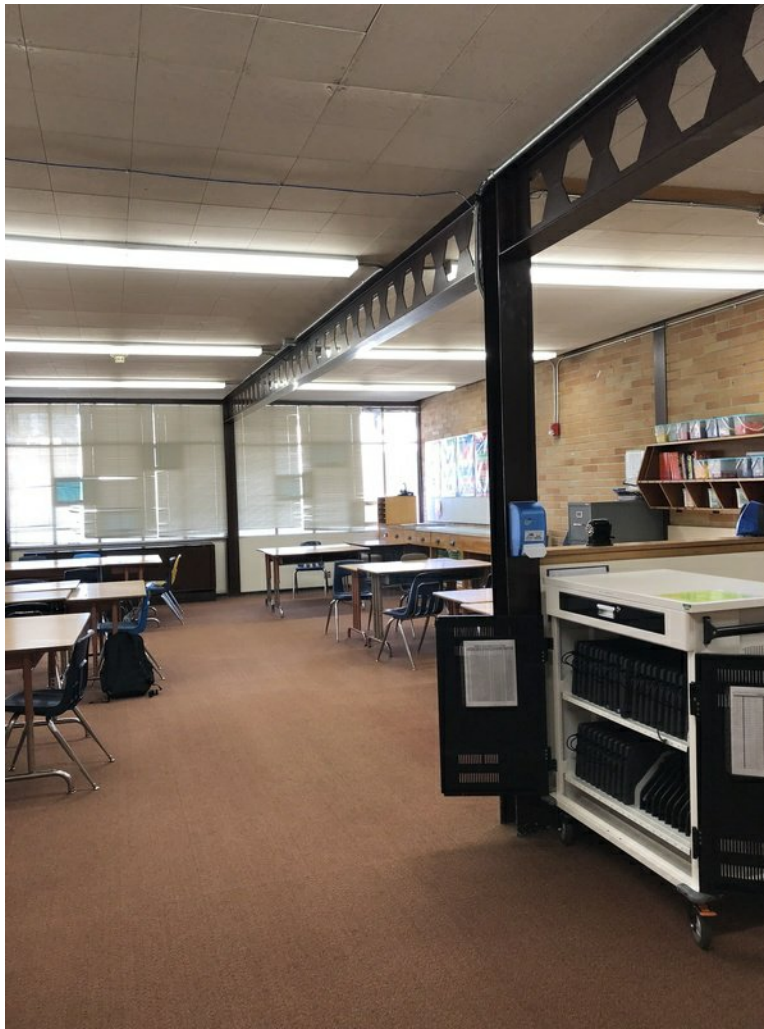
Figure 1-3. Typical classroom

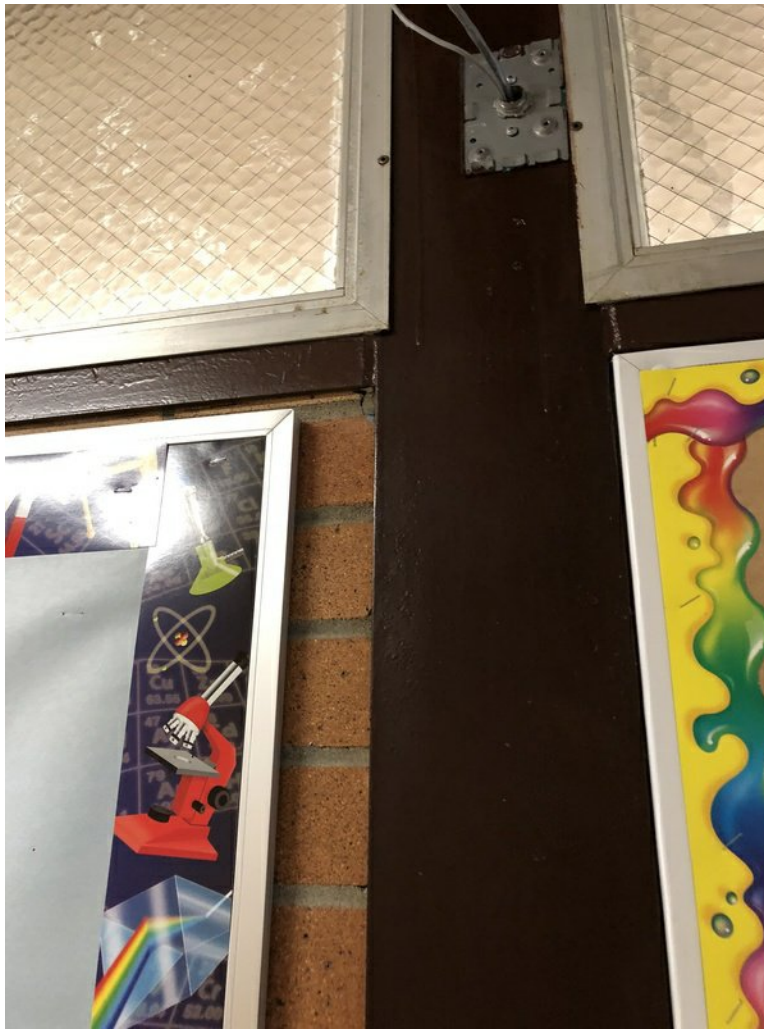
Figure 1-4. Face of WF column, brick infill corridor wall with steel channel cap

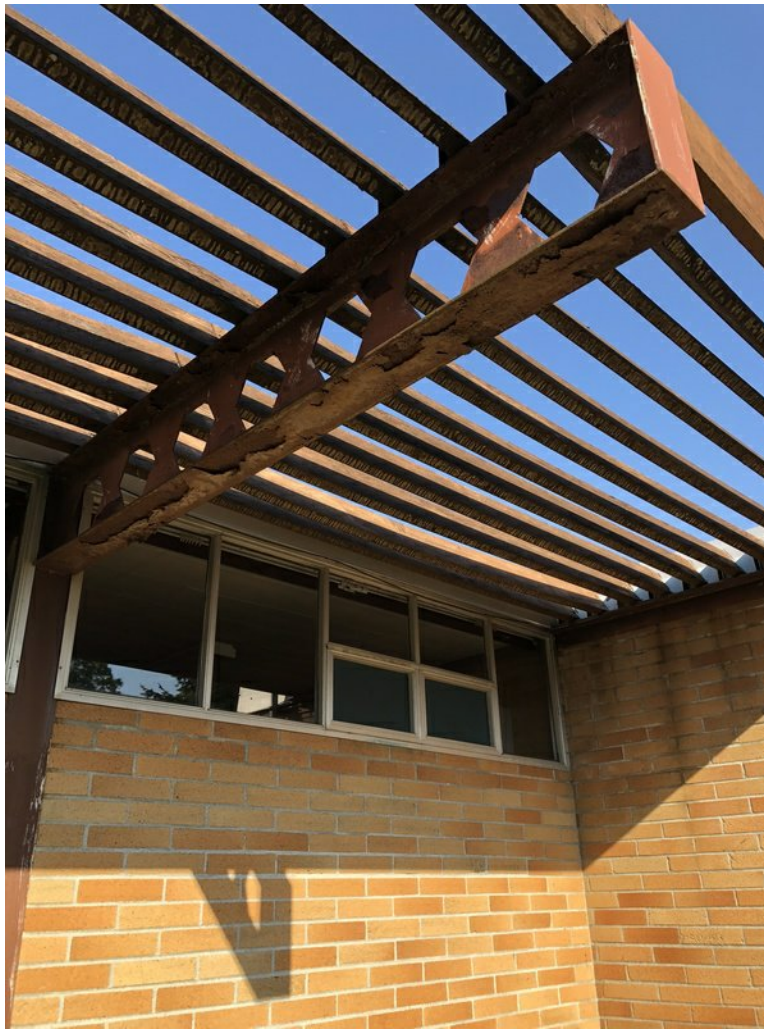
Figure 1-5. Corroded steel beam at northeast trellis overhang

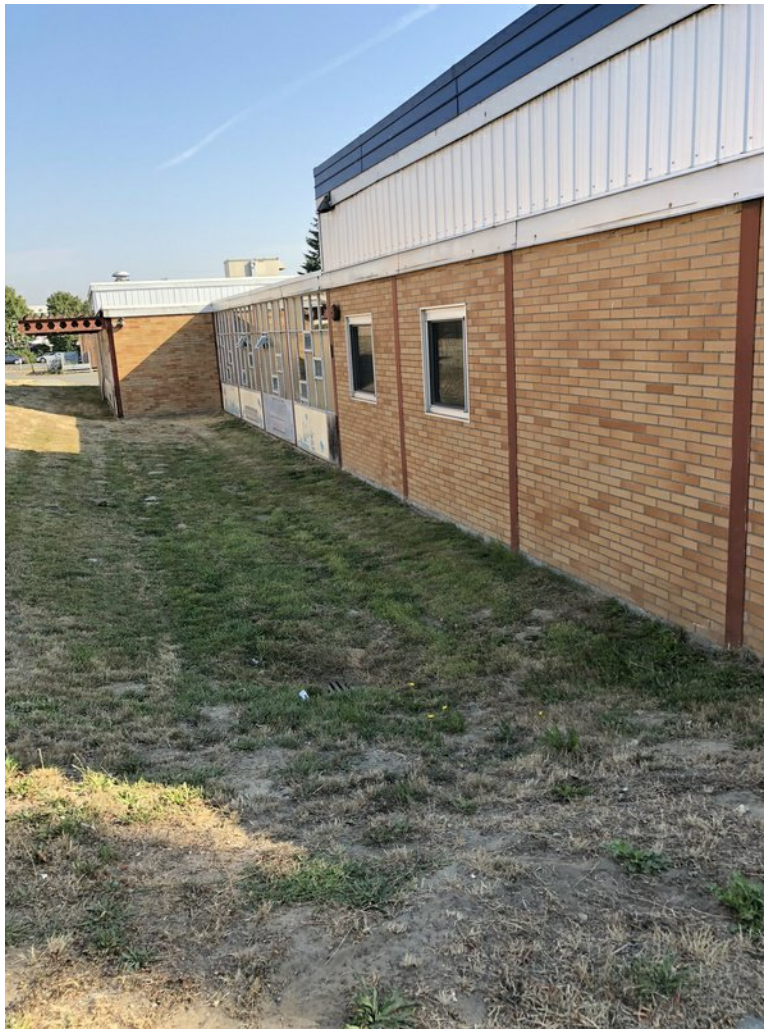
Figure 1-6. West exterior wall of Annex (looking northeast)

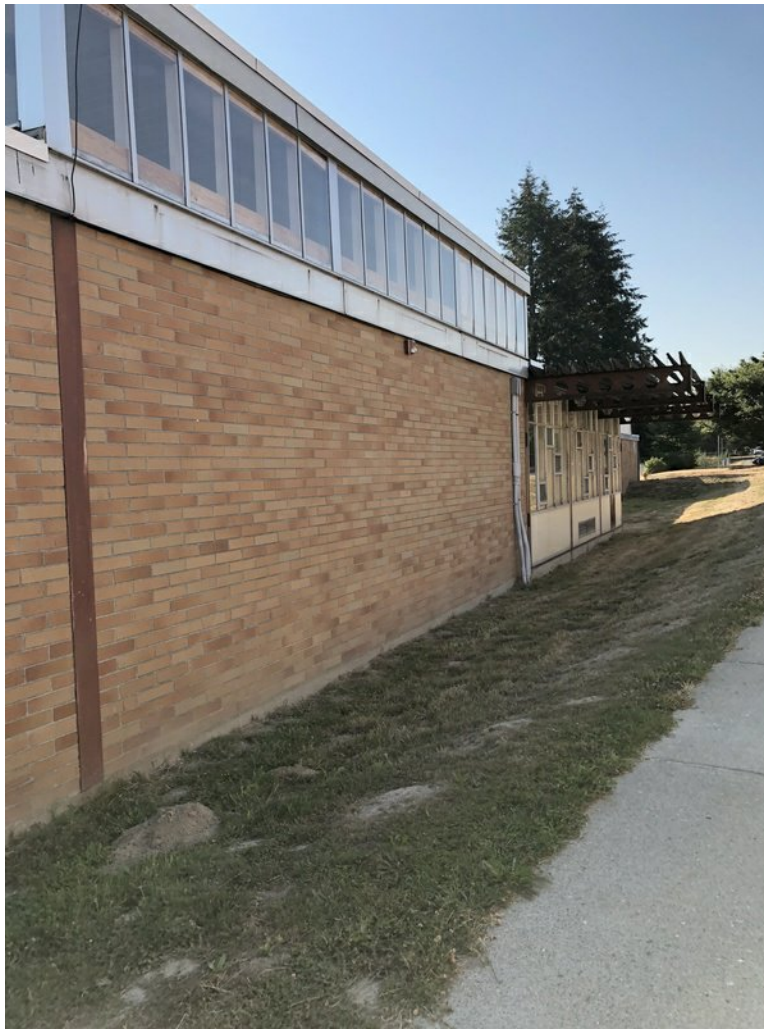
Figure 1-7. West exterior wall at high-bay of 1966 addition (looking south east)

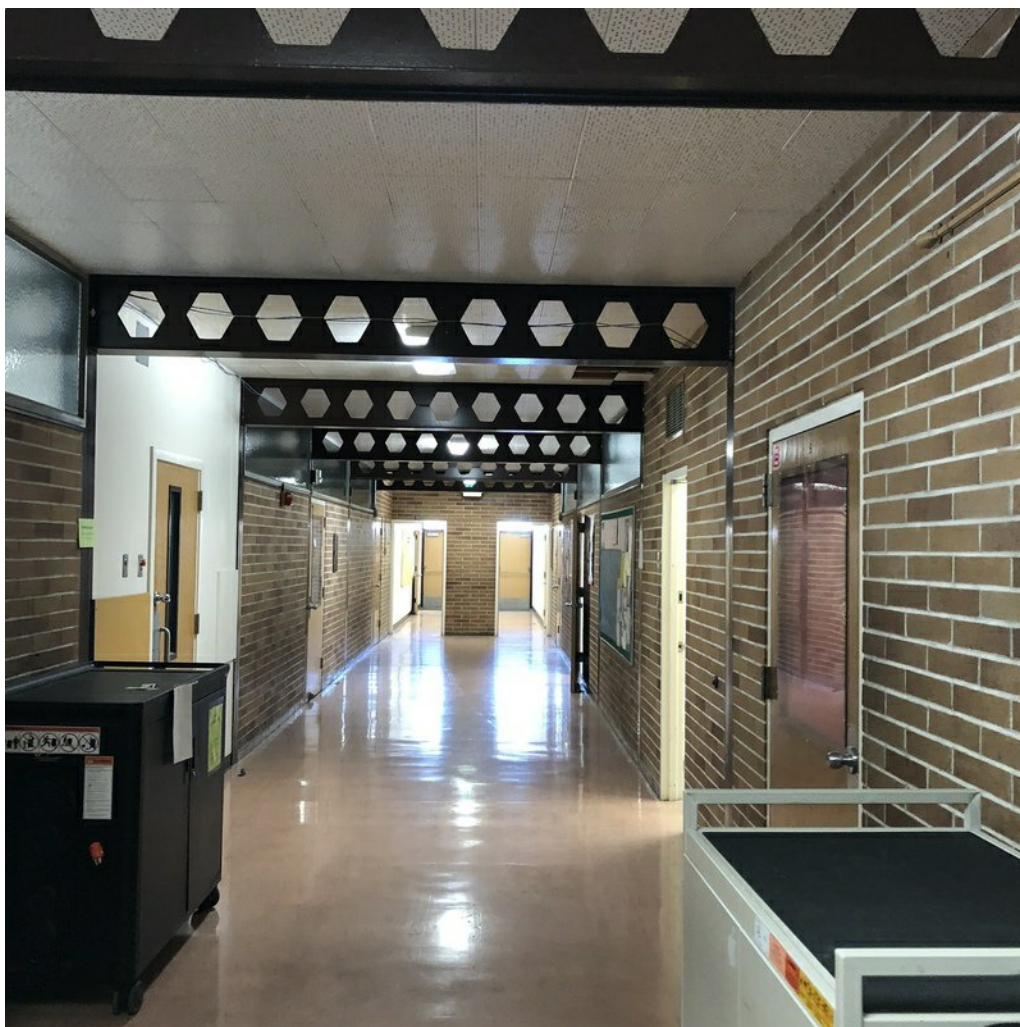
Figure 1-1. Castellated roof beams in corridor

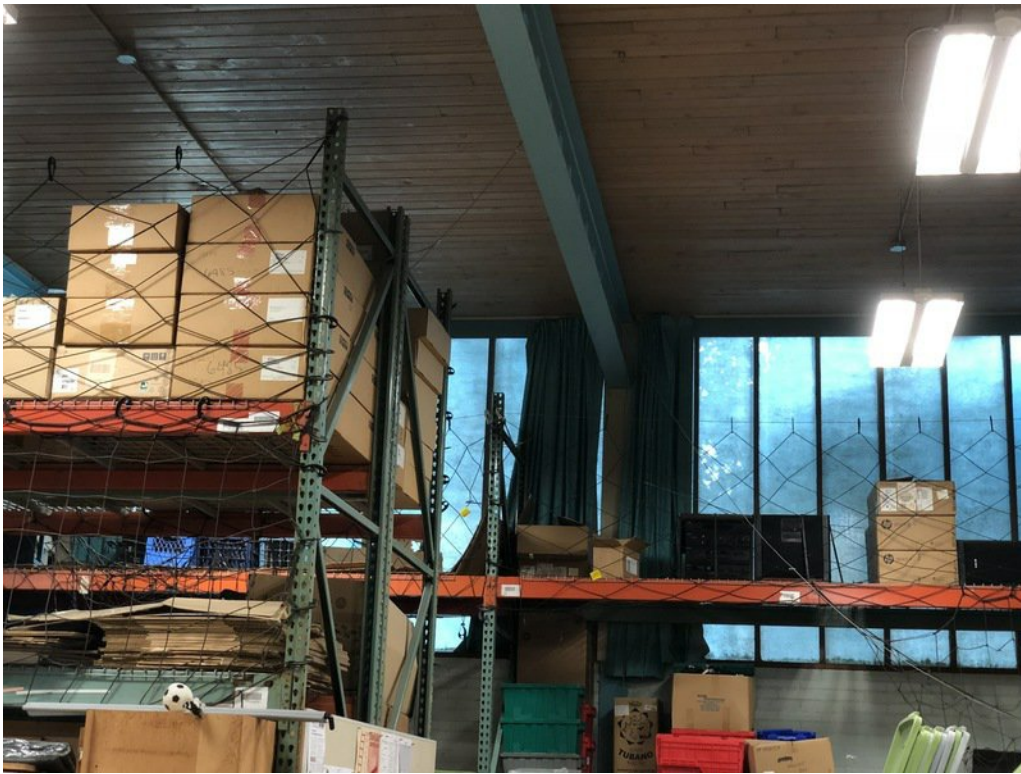
Figure 1-2. General storage in former gym, fiberglass panels in east exterior wall of gym (looking east)

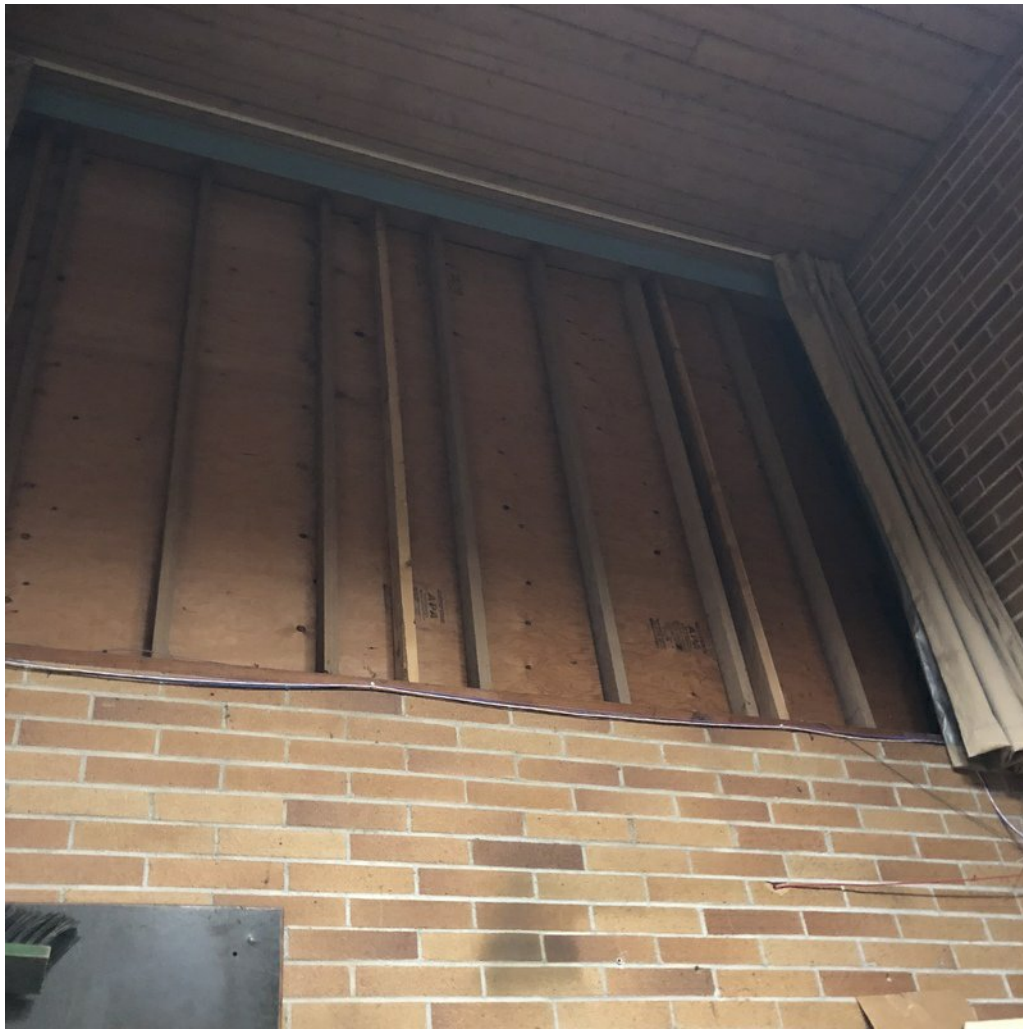
Figure 1-3. West wall of gym with partial height brick masonry infill and sheathed stud wall to roof diaphragm

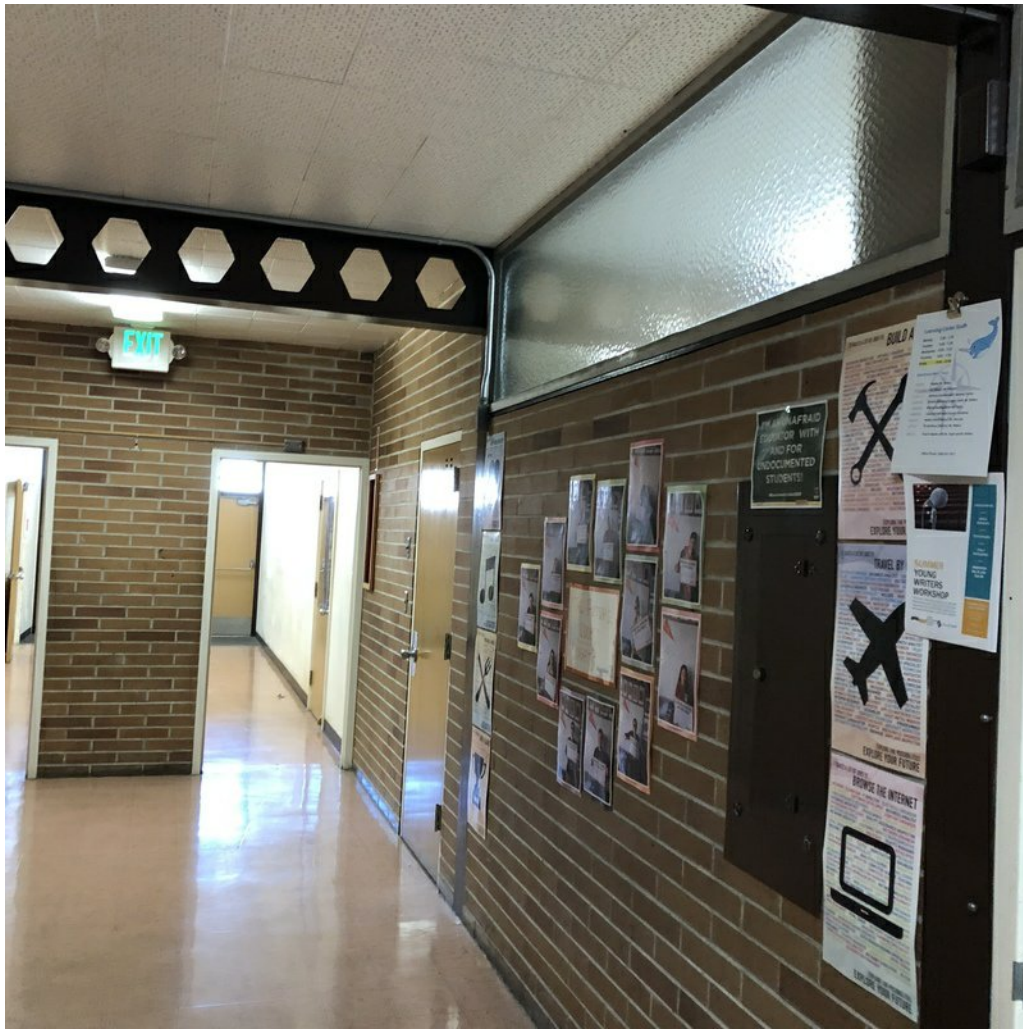
Figure 1-4. Typical corridor wall in classroom wing with partial height masonry wall with upper band of glazing

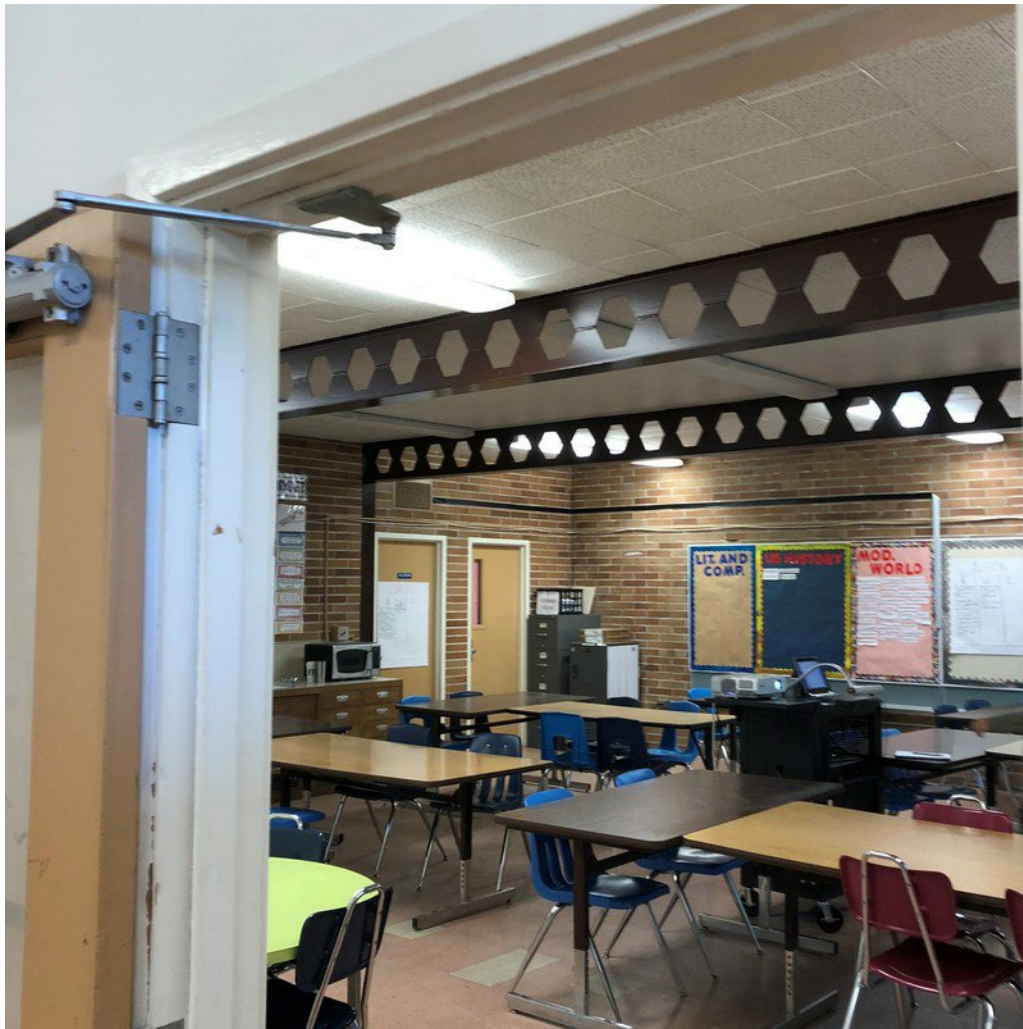
Figure 1-5. Typical classroom with exposed castellated beams and full height brick masonry walls

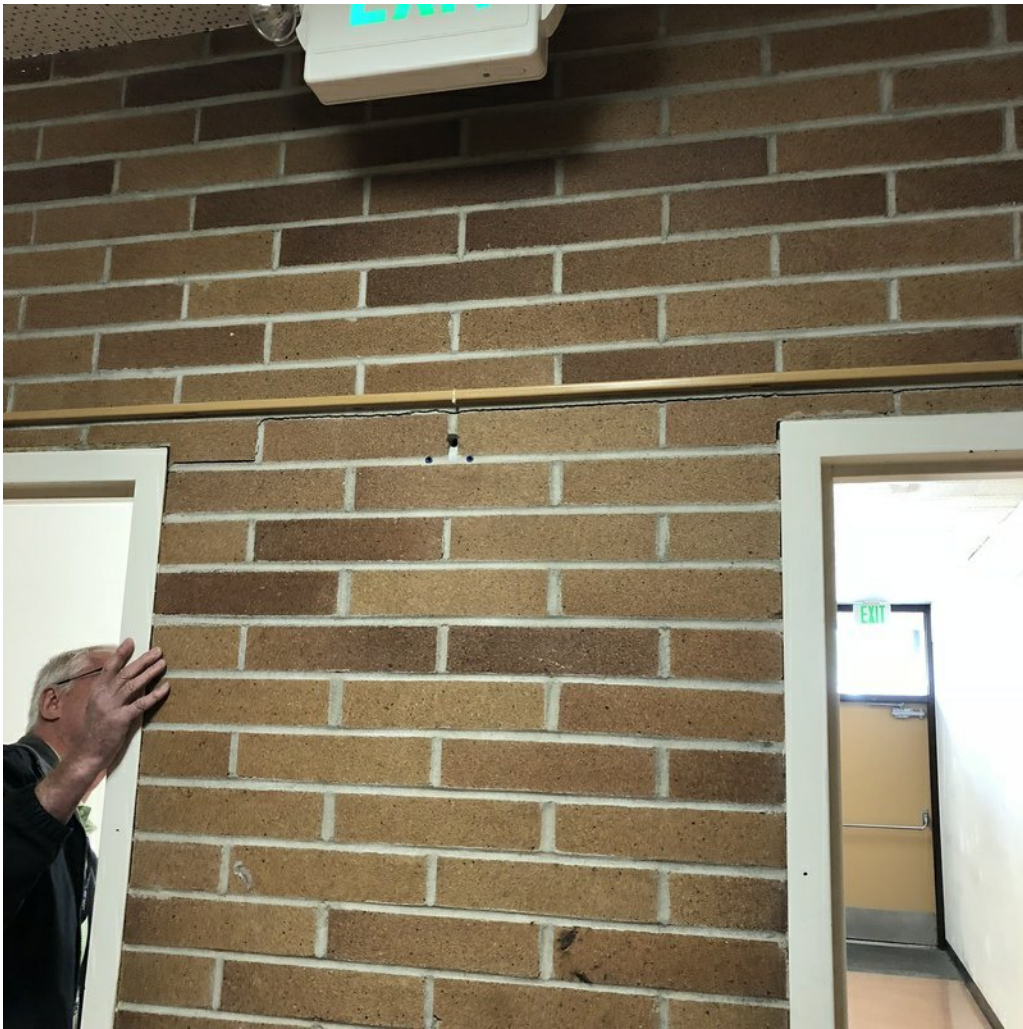
Figure 1-6. Horizontal crack in brick masonry partition wall at the west end of the corridor of the north classroom wing

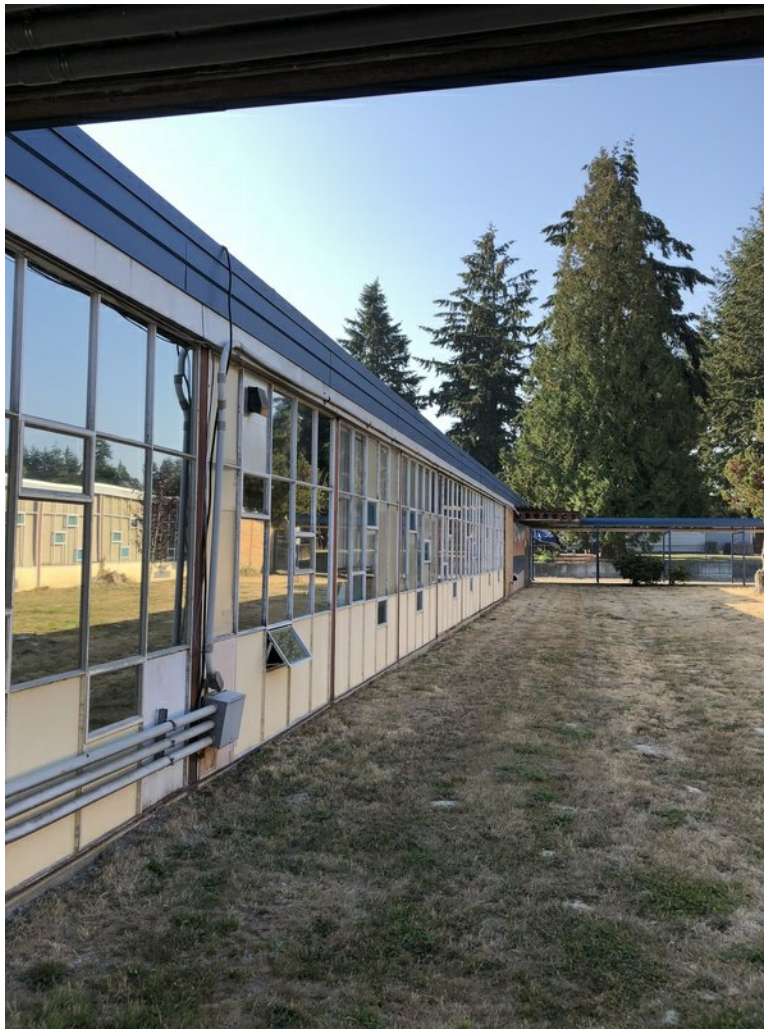
Figure 1-7. West exterior wall of south classroom wing

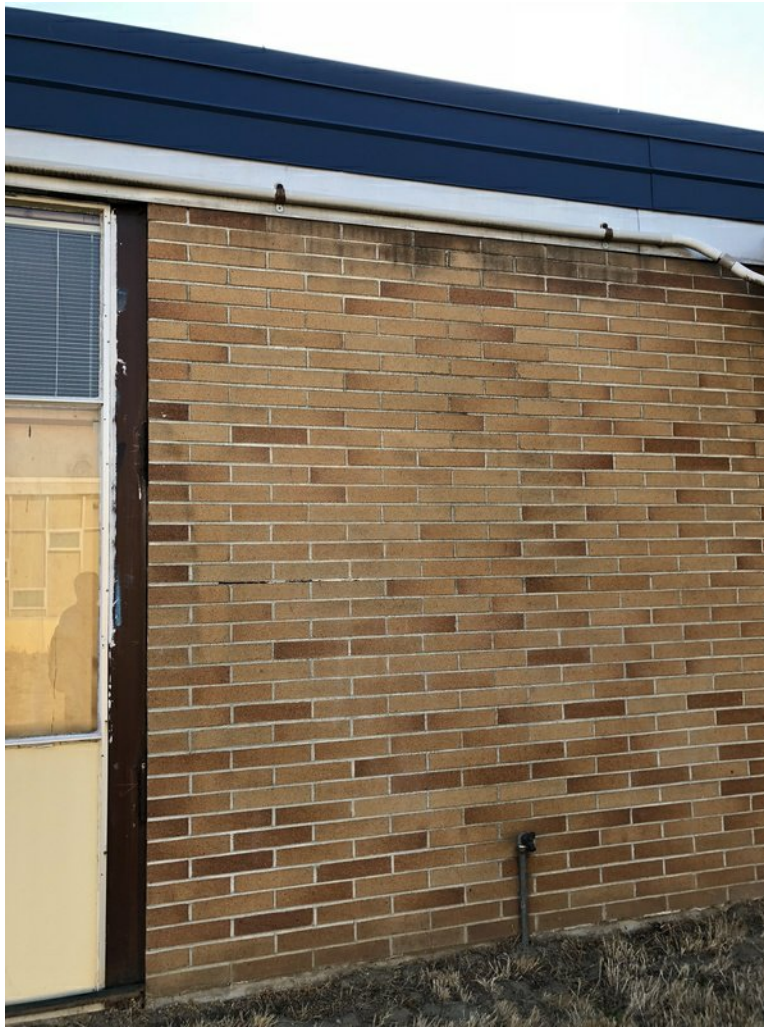
Figure 1-8. Exterior brick infill wall and exposed flange of steel WF column
